# Manhole Inspection Summary

Manhole # S53I\_\_009MH

Insp Date: **2/27/09 12:01 PM**

**Location** Address: **3129 eastern av**

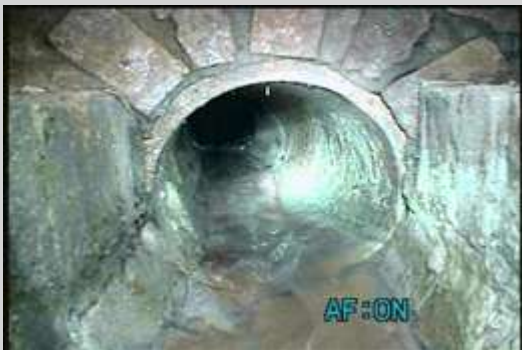
12 O'Clock Outflow

8 in. Circular Gravity Sewer  
Pipe Out @ 12 O'Clock

Pipe Material: **Clay** ☐ Pipe Lined

Invert Depth: **10.10** (ft.) Flow Characteristics: **Fast**

Deposits: ☒ None ☐ Mud ☐ Sludge ☐ Debris ☐ Grease

Infiltration: **None** Pipe Seal Cond: **Unknown**

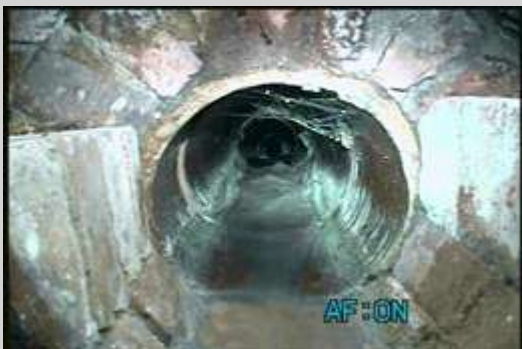
3 O'Clock Inflow

8 in. Circular Gravity Sewer  
Pipe In @ 3 O'Clock

Pipe Material: **Clay** ☐ Pipe Lined

Infiltration: **None** Pipe Seal Cond: **Unknown**
